Evaluation Of Progressive Collapse Due to Fire in High-Rise Steel Structures with Eccentrically Bracing

Abstract

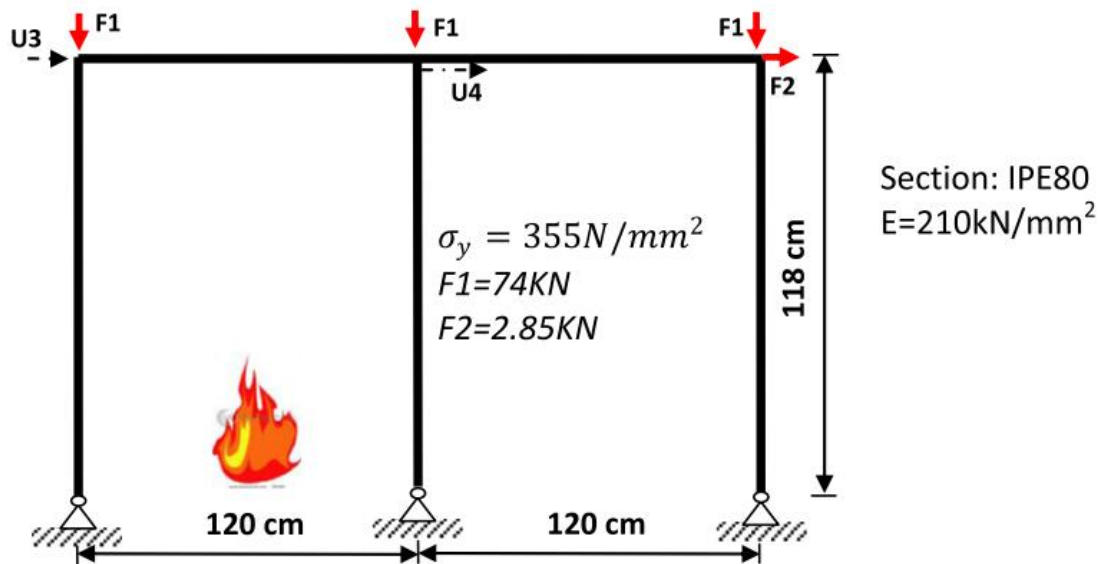
Figure 1: Specifications of the validation sample [1].

As seen in Figure 1, the verification sample is a frame with two openings and one floor, the dimensions of the opening are 120 cm and the height of each floor is 118 cm, and its cross section is IPE80 for It is a beam and a column. A fire has been made in the left opening. For modeling in the validation section, a two-dimensional beam model has been used in Abaqus, and a schematic of the drawing geometry in Abaqus software is presented in Figure 2.

The reference article¹ was used to verify the results. The specifications of the model analyzed in this article are presented in Figure 1.

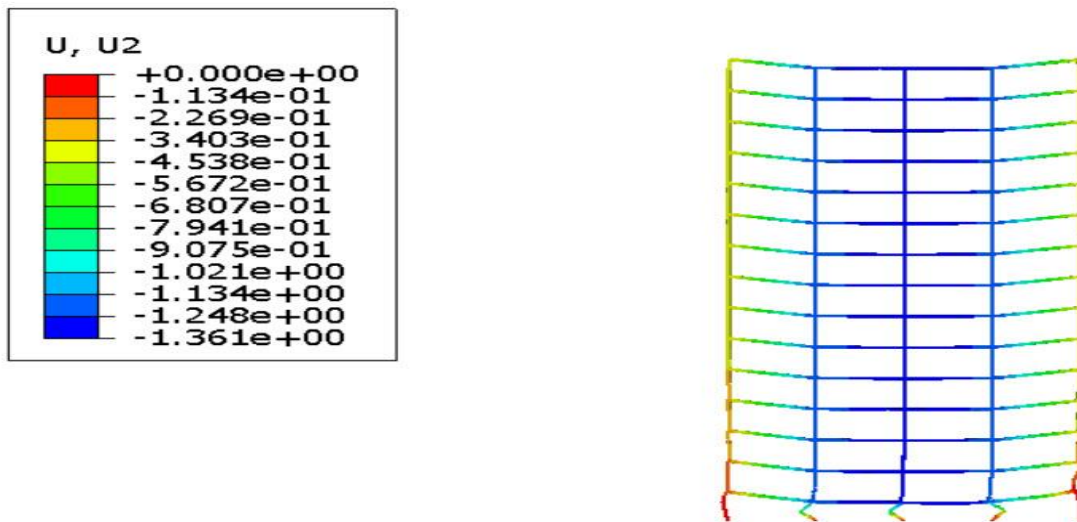
Figure 3: The largest displacement in thermal analysis in model number 1 (simple frame, 15-floor model, fire place in the middle of the first floor of the structure).

A schematic of the deformation in models 1 to 4 is presented in Figures 3 to 6. In these models, the structure is 15 stories without braces, in model number 1, the fire place is on the first and middle floor column, in model number 2, the fire place is on the first floor column and side, in model number 3, The place of fire is on the column of the middle and middle floor, and in model number 4, the place of fire is on the column of the middle floor and on the side of the structure.

- 1- In the 15-floor structure without braces (examples 1 to 4), the maximum displacement is related to model number 1 and 2, both of these structures are caused by fire and thermal load on its column. It has undergone many deformations and progressive deterioration. In model number 3 and 4, the structure has been able to resist the incoming loads to some extent and the reason for this is that the loads on the column in the middle floor are much less than the lower floor and for this reason by removing one column As a result of the fire, the structure has been able to withstand the loads with the help of the rest of the columns and the structure has not undergone many deformations. Therefore, in a 15-floor structure without the worst scenario, removing the column in the lower middle floor, then the lower side floor, and then the middle floor of the middle column, and finally, the least damage is related to the removal of the column in the middle and side floors.

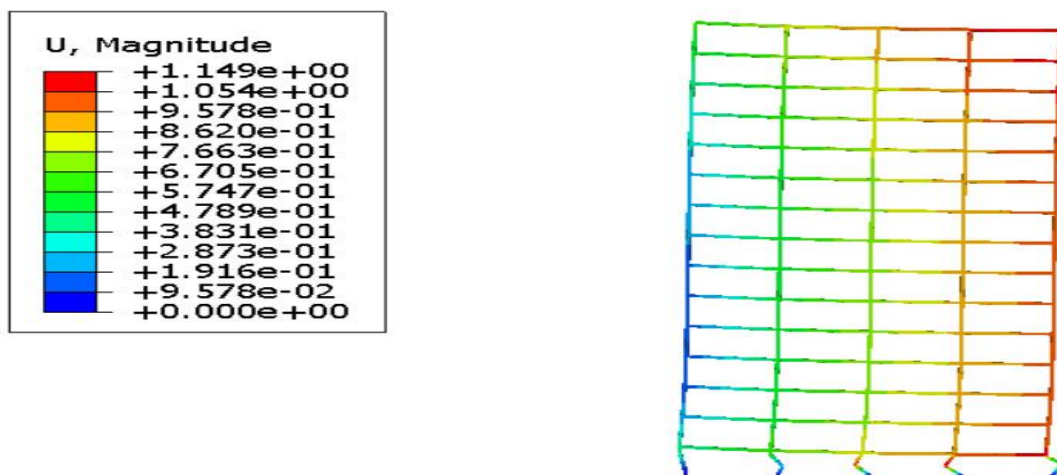
Figure 4: The largest displacement in thermal analysis in model number 2 (simple frame, 15-floor model, fire location next to the first floor of the structure)

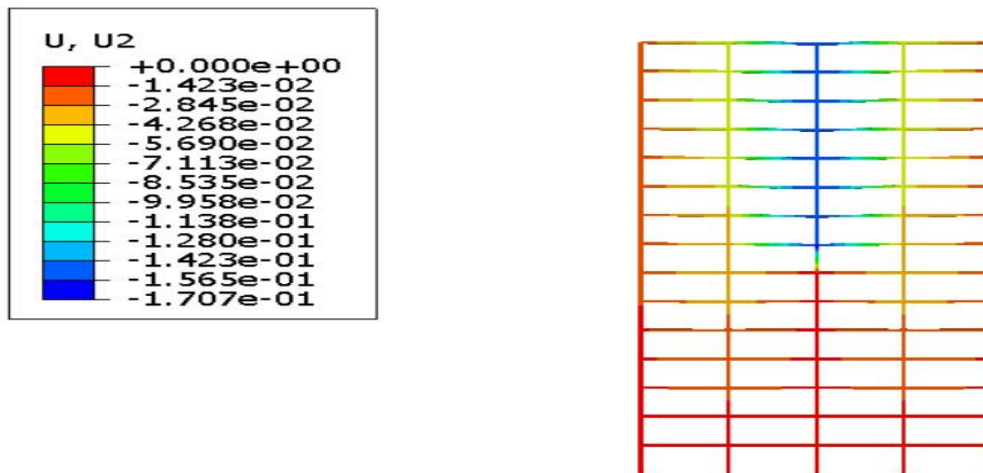
Figure 5: The largest displacement in thermal analysis in model number 3 (simple frame, 15-floor model, fire place in the middle of the middle floor of the structure)

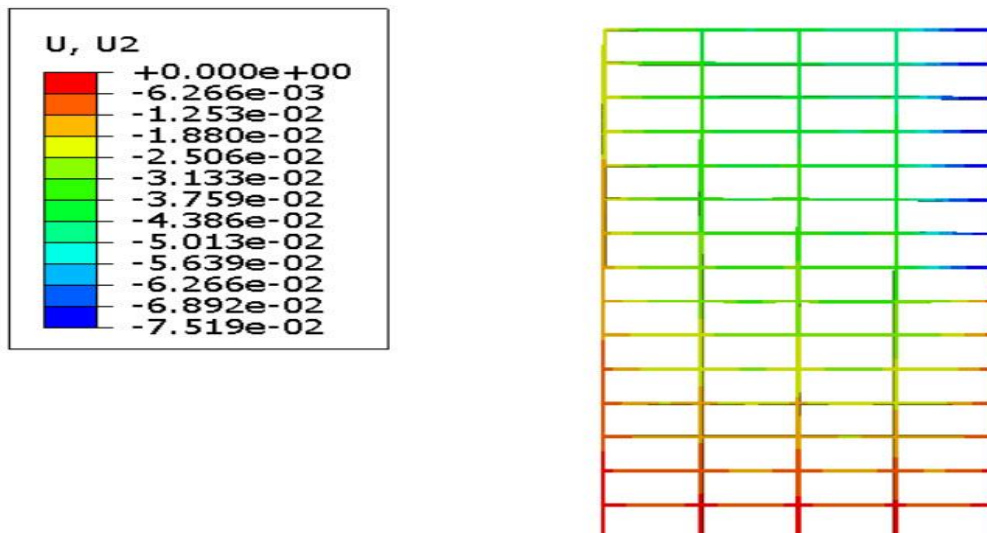
Figure 6: The highest displacement in thermal analysis in model number 4 (simple frame, 15-floor model, fire location next to the middle floor of the structure)

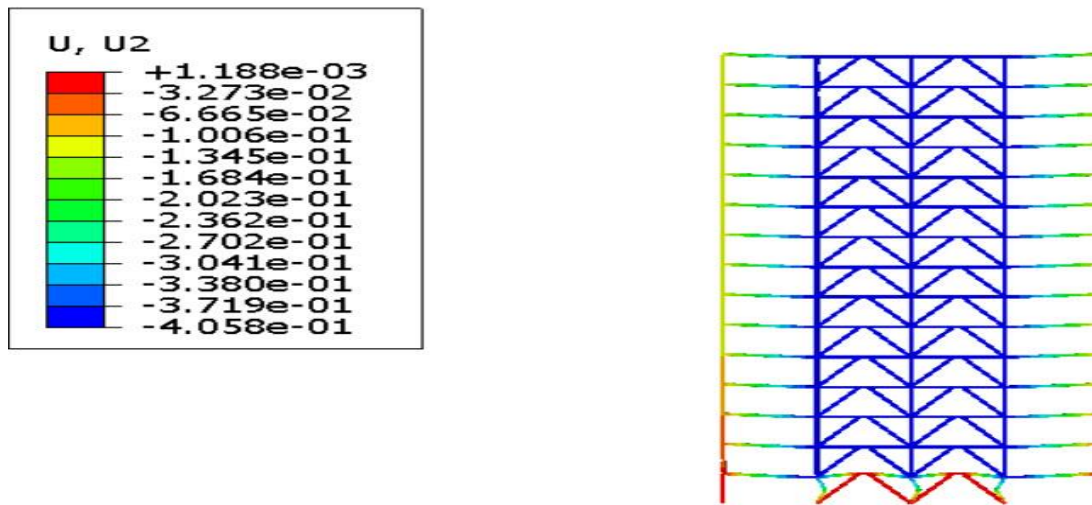
Figure 7: The highest displacement in thermal analysis is in model number 5 (frame with divergent brace, 15-floor model, fire place in the middle of the first floor of the structure)

A schematic of the deformation in models 5 to 8 is presented in Figure 7 to 10. In these models, the structure has 15 floors and has braces. In model number 5, the fire location is on the column of the first floor in the middle, in model number 6, the fire location is on the column of the first floor and on the side, in model number 7, the location The fire is on the column of the middle and middle floor and in model number 8, the place of fire is on the column of the middle floor and on the side of the structure.

- 2- In the samples analyzed in the 15-floor structure and with divergent braces in models 5 to 8, in all 4 models, the maximum amount of displacement due to the application of heat in the models compared to the simple frame without divergent braces with a decrease has been In this category, except for sample number 5, in the rest of the samples, the structure has been able to show good resistance, and with increasing temperature and removal of a column, progressive failure has occurred only in structure number 5.

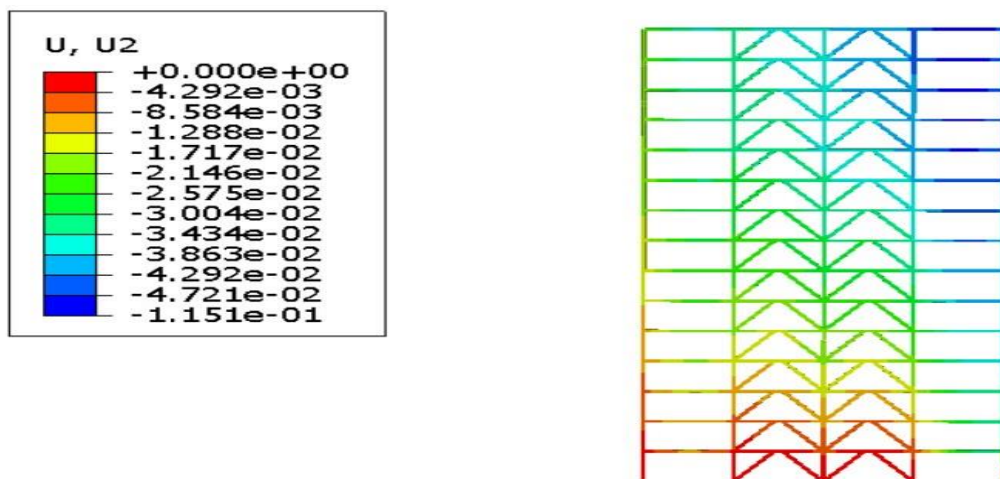
Figure 8: The highest displacement in thermal analysis in model number 6 (frame with divergent brace, 15-floor model, fire location next to the first floor of the structure)

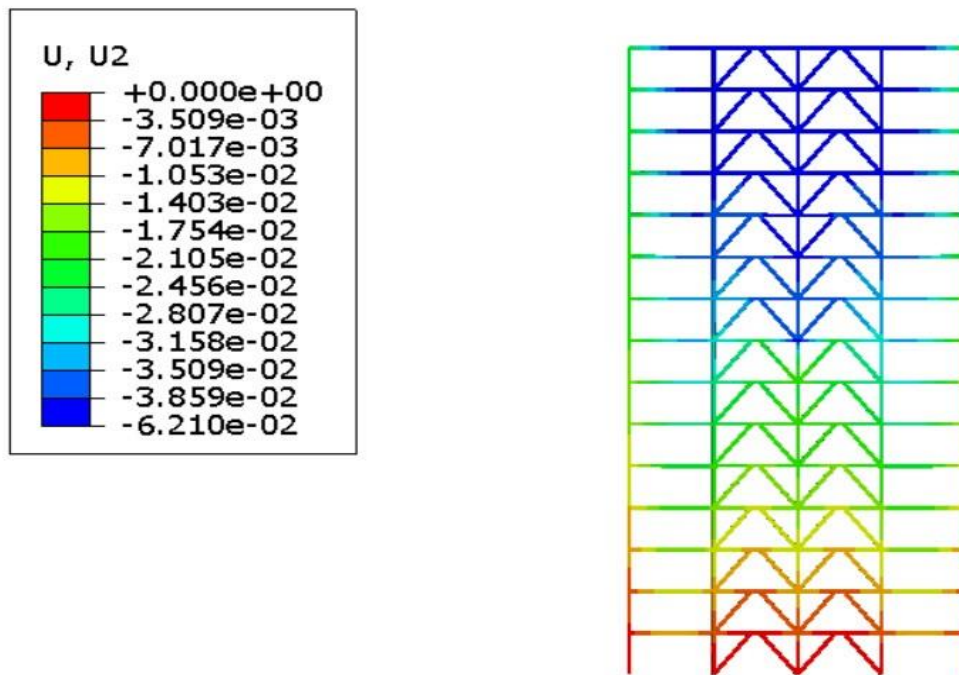
Figure 9: The highest displacement in thermal analysis in model number 7 (frame with divergent brace, 15-floor model, fire location in the middle of the middle floor of the structure)

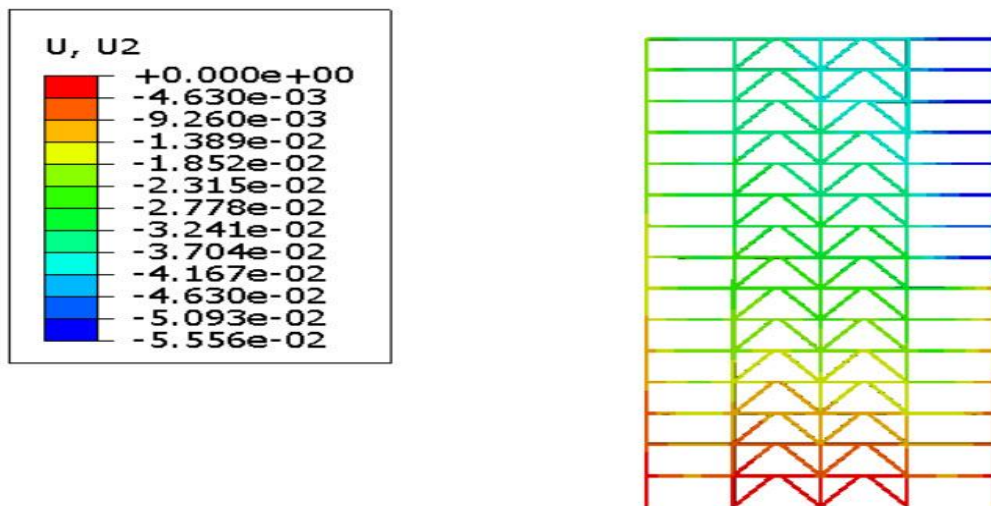
Figure 10: The highest displacement in thermal analysis is in model number 8 (frame with divergent brace, 15-floor model, fire location next to the middle floor of the structure).

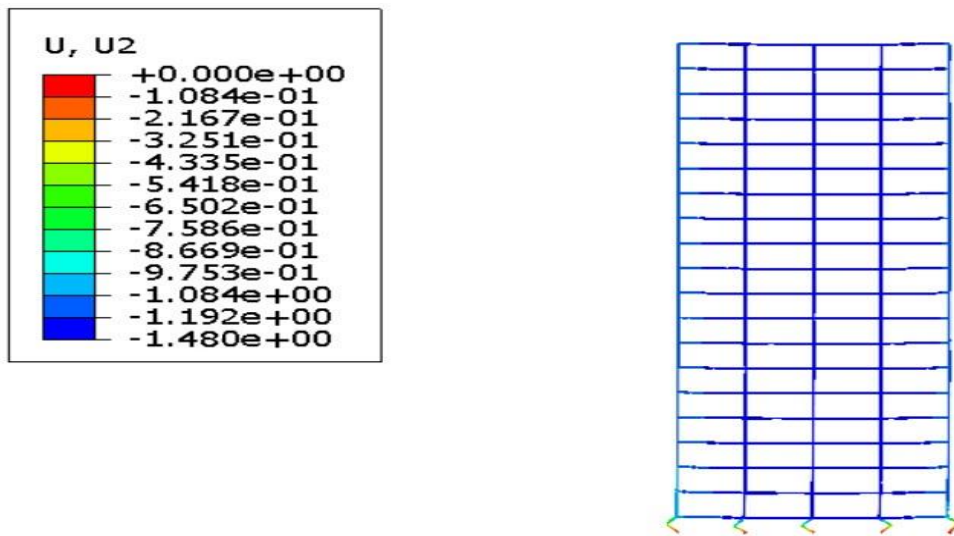
Figure 11: The highest displacement in thermal analysis in model number 9 (simple frame, 20-floor model, fire place in the middle of the first floor of the structure)

A schematic of the deformation in models 9 to 12 is presented in Figure 11 to 14. In these models, there is a 20-floor structure without braces, on which 4 fire scenarios similar to models 1 to 4 have been applied, the first two samples of the column of the first floor and the second two samples of the column of the tenth floor are exposed to fire. is placed).

- 3- In samples number 9 to 12, there were 20-floor structures without braces, and both structures 9 and 10, due to the fire and the thermal load on the column, suffered large deformations and progressive damage. has been In model number 11 and 12, the structure has been able to withstand the loads to a large extent and the reason for this is that the loads on the column in the middle floor are much less than the lower floor and for this reason by removing a Due to the fire of the structure, the column has been able to resist the loads with the help of the other columns and the structure did not undergo many deformations. In these models, compared to the 15-floor models, in all 4 models, the deformations have increased up to 40% due to the increase in loads on the structure due to the increase in height, and samples 11 and 12 also have displacements. They are a little upright, but they are prone to collapse due to progressive damage

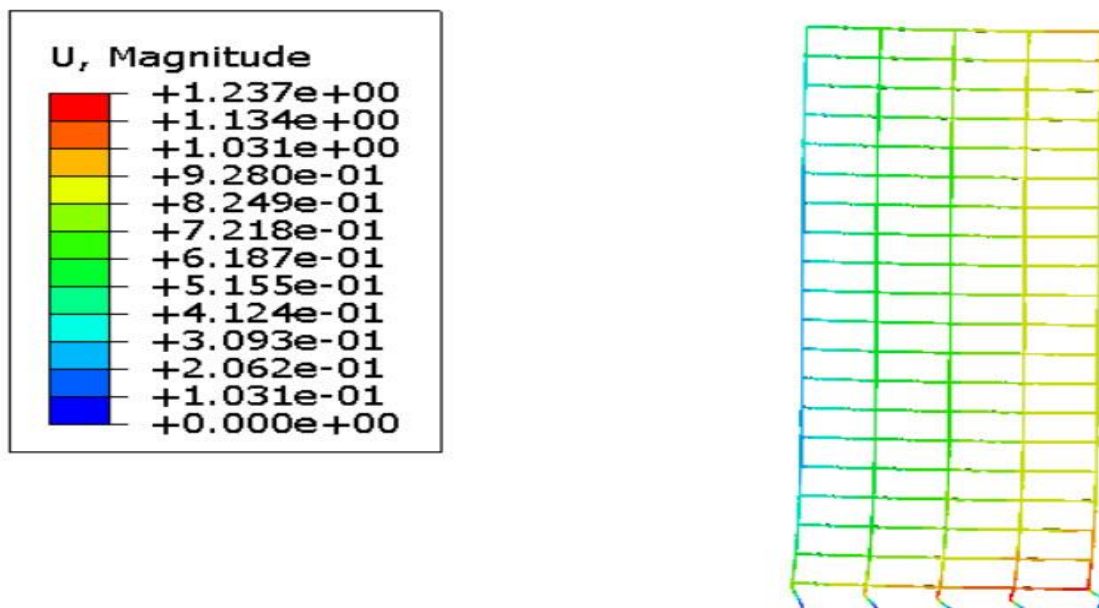
Figure 12: The highest displacement in thermal analysis in model number 10 (simple frame, 20-floor model, fire location next to the first floor of the structure)

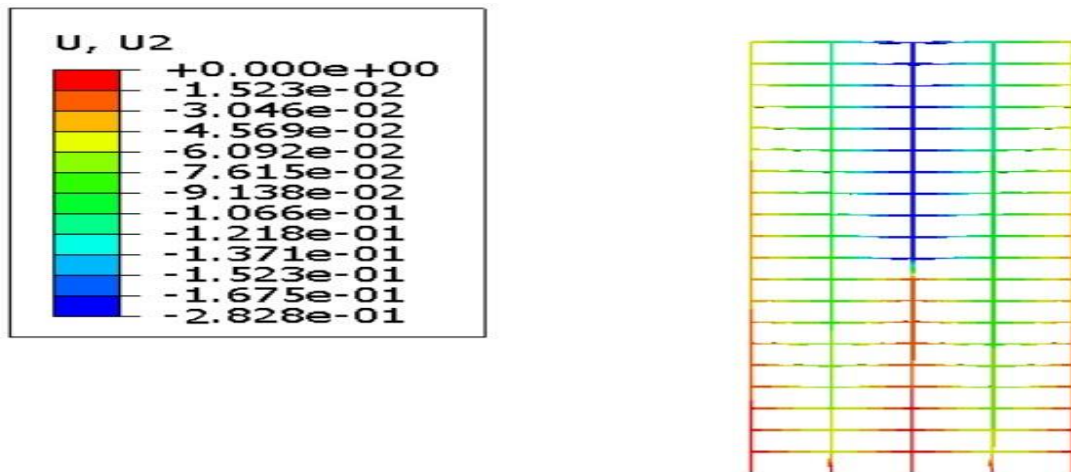
Figure 13: The highest displacement in thermal analysis in model number 11 (simple frame, 20-floor model, fire location in the middle of the middle floor of the structure)

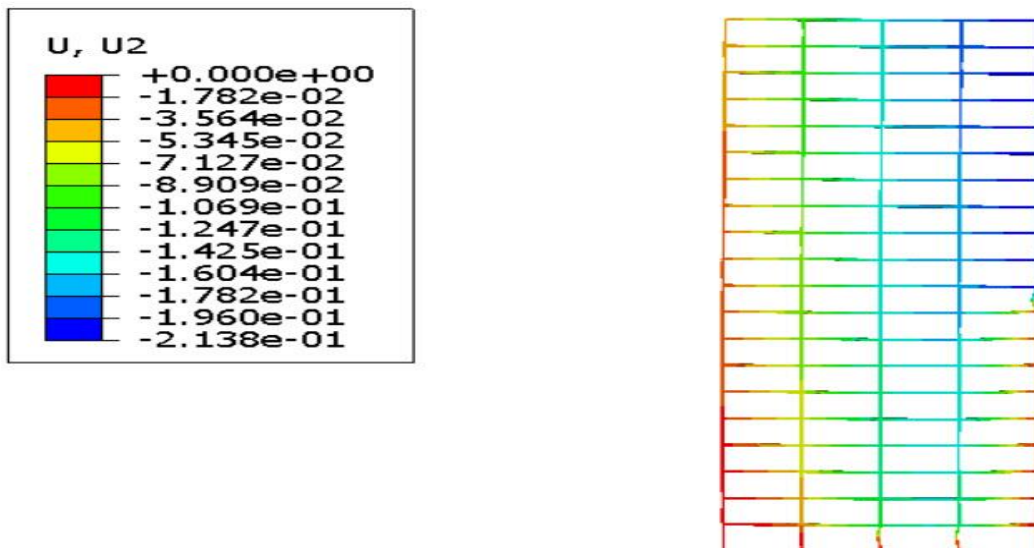
Figure 14: The highest displacement in thermal analysis in model number 12 (simple frame, 20-floor model, fire location next to the middle floor of the structure)

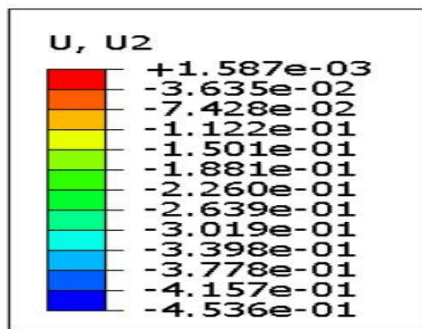
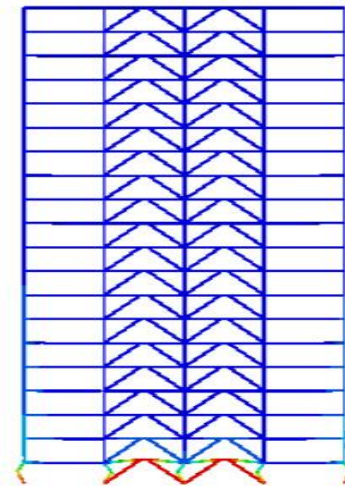
Figure 15: The highest displacement in thermal analysis in model number 13 (frame with diverging brace, 20-floor model, fire place in the middle of the first floor of the structure)

A schematic of the deformation in models 13 to 16 is presented in Figure 15 to 18. In these models, the structure has 20 floors and has braces. In model number 13, the fire location is on the column of the first floor in the middle, in model number 14, the fire location is on the column of the first floor and on the side, in model number 15, the location The fire is on the column of the middle and middle floor and in model number 16, the place of fire is on the column of the middle floor and on the side of the structure.

- 4- In samples 13 to 16, in all 4 models of the 20-floor structure, the amount of maximum displacement due to the application of heat in the models compared to the simple frame without diverging braces was accompanied by a good reduction. In this category, except for sample number 13 and 14, in the rest of the samples, the structure has been able to show good resistance, and with the increase in temperature and the removal of a column, progressive failure has occurred in structures 13 and 14, and samples 15 and 16 have shown resistance. It has shown good resistance to progressive damage caused by fire. In this category, compared to the 15-floor samples with diverging braces, the amount of displacement has increased by 40%.

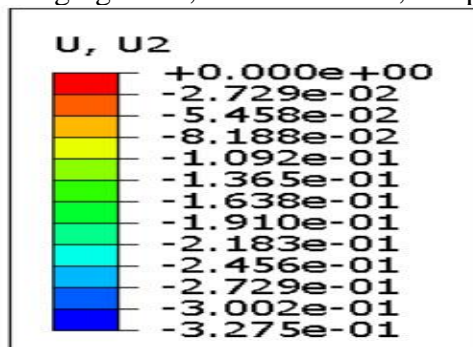
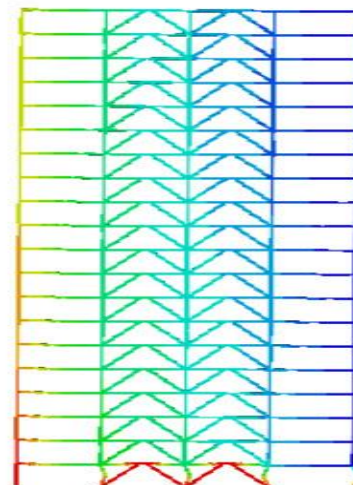
Figure 16: The largest displacement in thermal analysis in model number 14 (frame with divergent brace, 20-floor model, fire location next to the first floor of the structure)

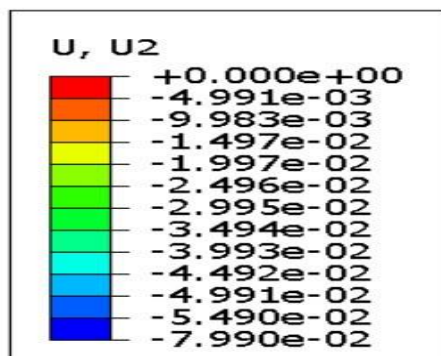
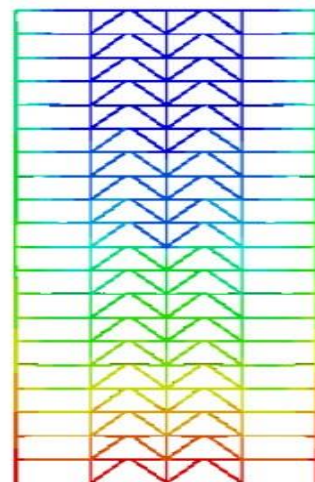
Figure17: The highest displacement in thermal analysis in model number 15 (frame with divergent brace, 20-floor model, fire place in the middle of the middle floor of the structure)

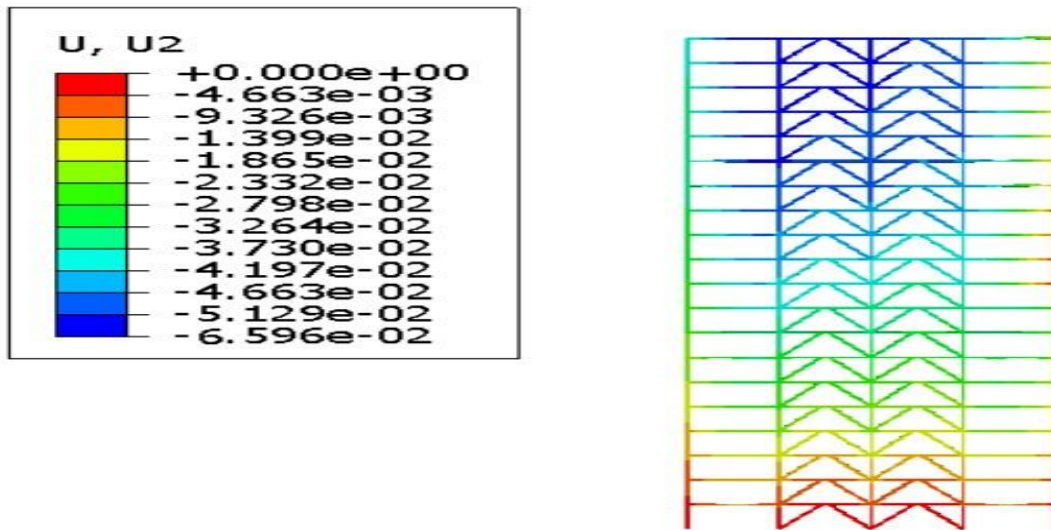
Figure 18: The highest displacement in thermal analysis in model number 16 (frame with divergent brace, 20-floor model, fire location next to the middle floor of the structure)

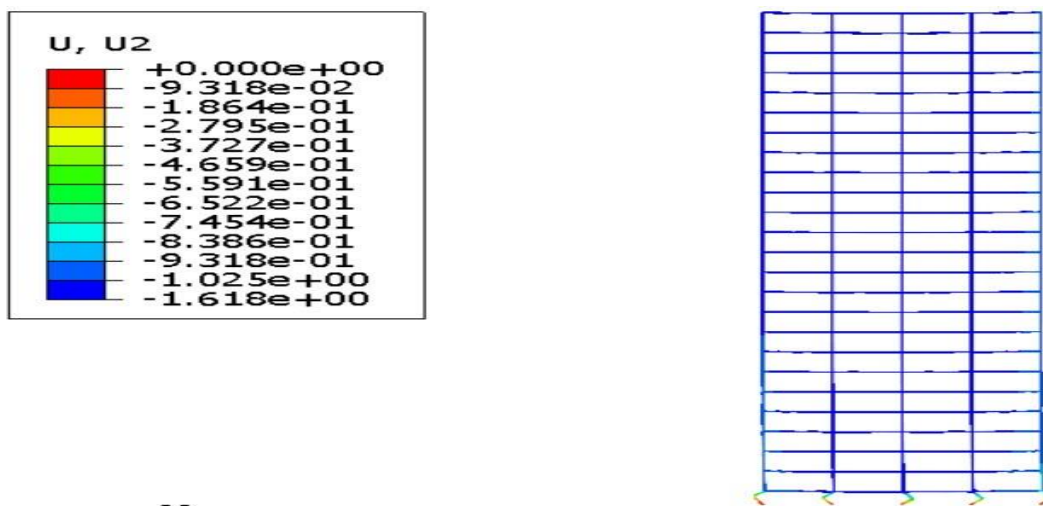
Figure 19: The highest displacement in thermal analysis is in model number 17 (simple frame, 25-floor model, fire place in the middle of the first floor of the structure).

In this section, the results related to models 17 to 20 are presented. In these models, there is a 25-floor structure without braces, on which 4 fire scenarios similar to models 1 to 4 have been applied, the first two samples of the column of the first floor and the second two samples of the column of the thirteenth floor are exposed to fire. is placed). The results of the maximum displacement are presented in Figures 19 to 22.

- 5- In the structures with 25 floors and without braces in all the samples, the structures have undergone many deformations and progressive damage due to the fire and the thermal load applied to its columns.

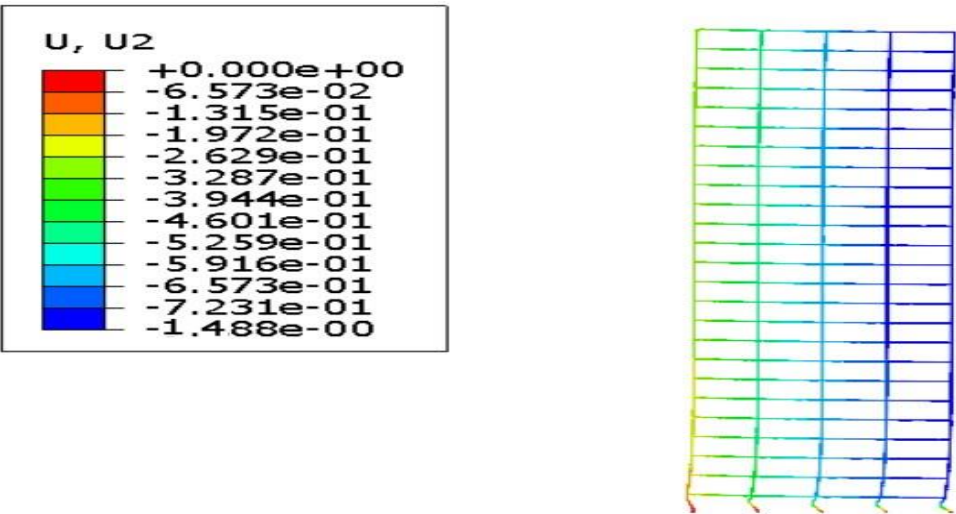
Figure 20: The highest displacement in thermal analysis in model number 18 (simple frame, 25-floor model, fire location next to the first floor of the structure)

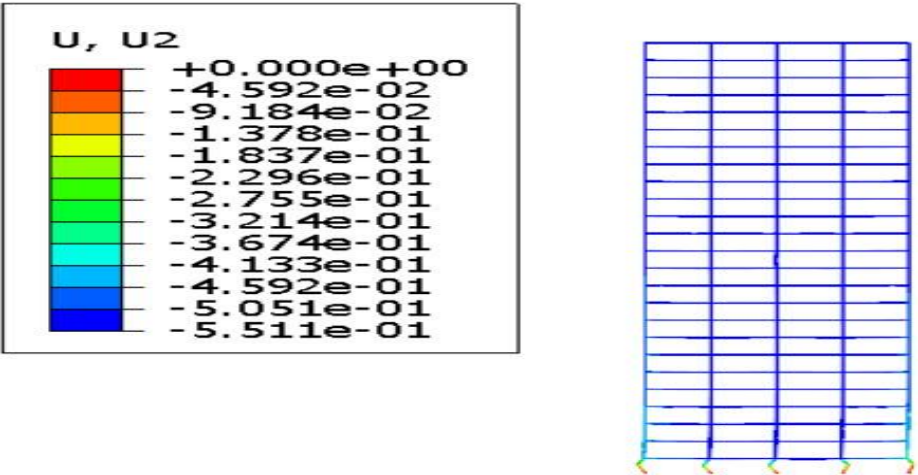
Figure 21 : The highest displacement in thermal analysis in model number 19 (simple frame, 25-floor model, fire place in the middle of the middle floor of the structure)

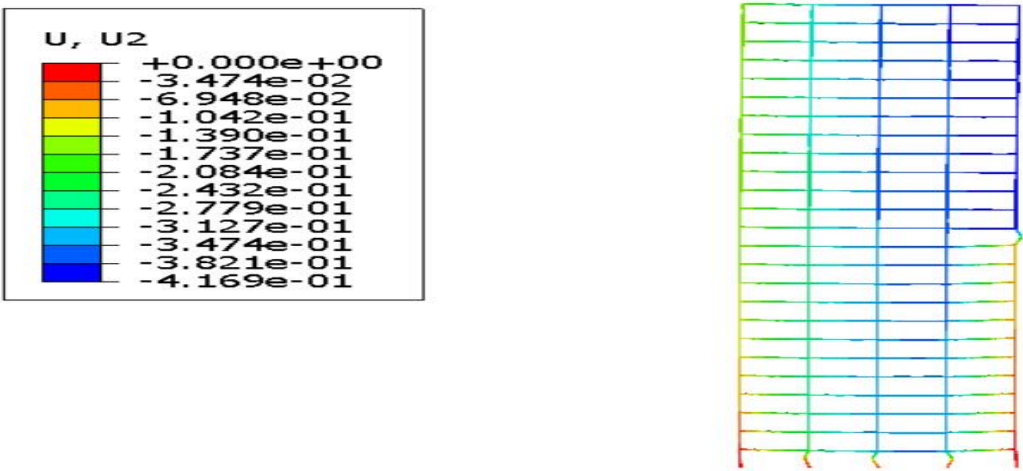
Figure 22: The highest displacement in thermal analysis in model number 20 (simple frame, 25-floor model, fire location next to the middle floor of the structure)

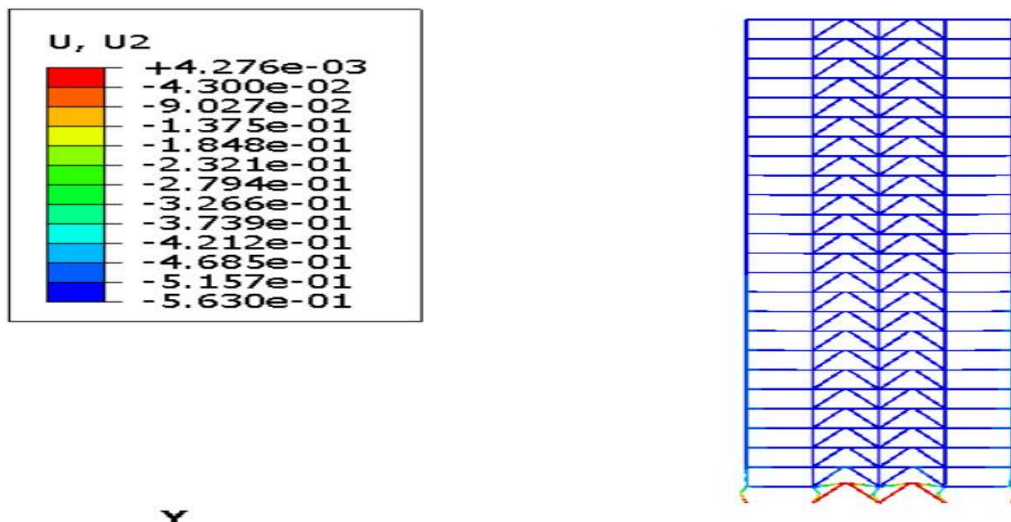
Figure 23: The highest displacement in thermal analysis in model number 21 (frame with divergent brace, 25-floor model, fire place in the middle of the first floor of the structure)

A schematic of the deformation in models 21 to 24 is presented in Figure 23 to 26. In these models, the structure has 25 floors and has braces, in model number 21, the place of fire is on the column of the first floor in the middle, in model number 22, the place of fire is on the column of the first floor and on the side, in model number 23, the place The fire is on the column of the middle and middle floor and in model number 24, the place of fire is on the column of the middle floor and on the side of the structure.

sample number 21 and 22, in the rest of the samples, the structure has been able to show good resistance, and with the rise in temperature and the removal of a column, progressive damage has occurred in structures 21 and 22, and samples 23 and 24 have good resistance to progressive damage caused by fire from has shown itself. In this category, compared to the samples of 15 and 20 floors with diverging braces, the amount of displacement has increased by 30%.

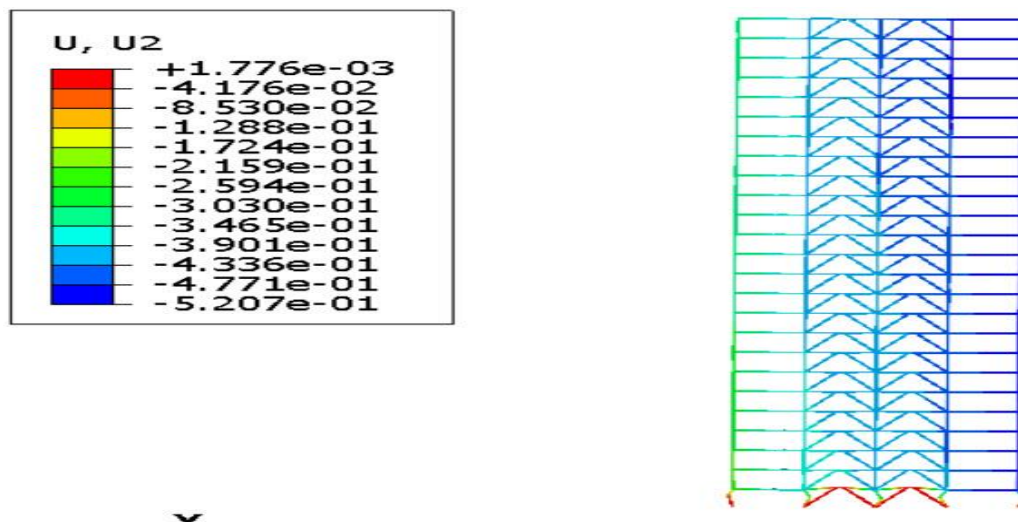
Figure 24: The highest displacement in thermal analysis in model number 22 (frame with divergent brace, 25-floor model, fire location next to the first floor of the structure)

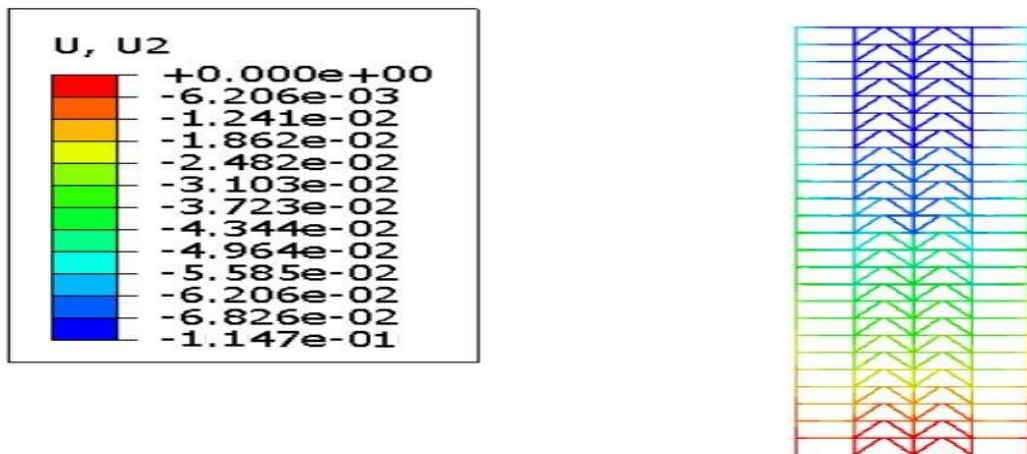
Figure 25: The highest displacement in thermal analysis in model number 23 (frame with divergent brace, 25-floor model, fire location in the middle of the middle floor of the structure)

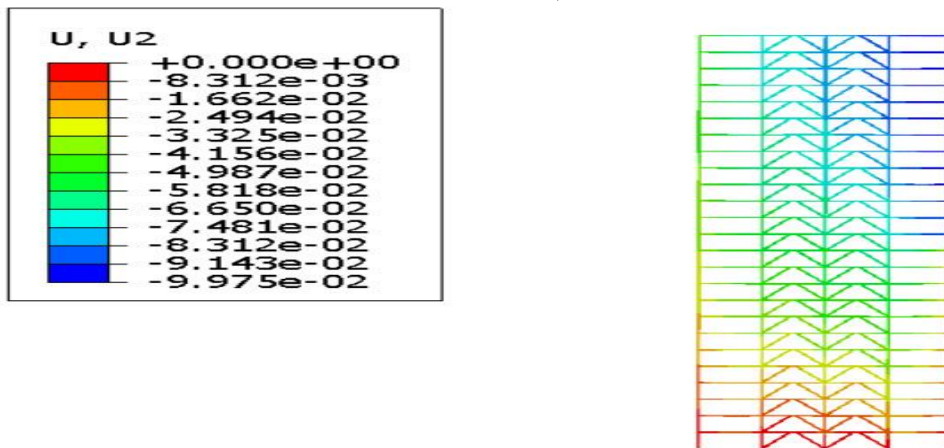
Figure 26: The highest displacement in thermal analysis is in model number 24 (frame with divergent brace, 25-floor model, fire location next to the middle floor of the structure)
